# ATTACHMENT 8: 2017 Study

## General Mitchell International Airport 2017 Roof Survey & Budget Projections

December 2017

RE: Facility Inspection

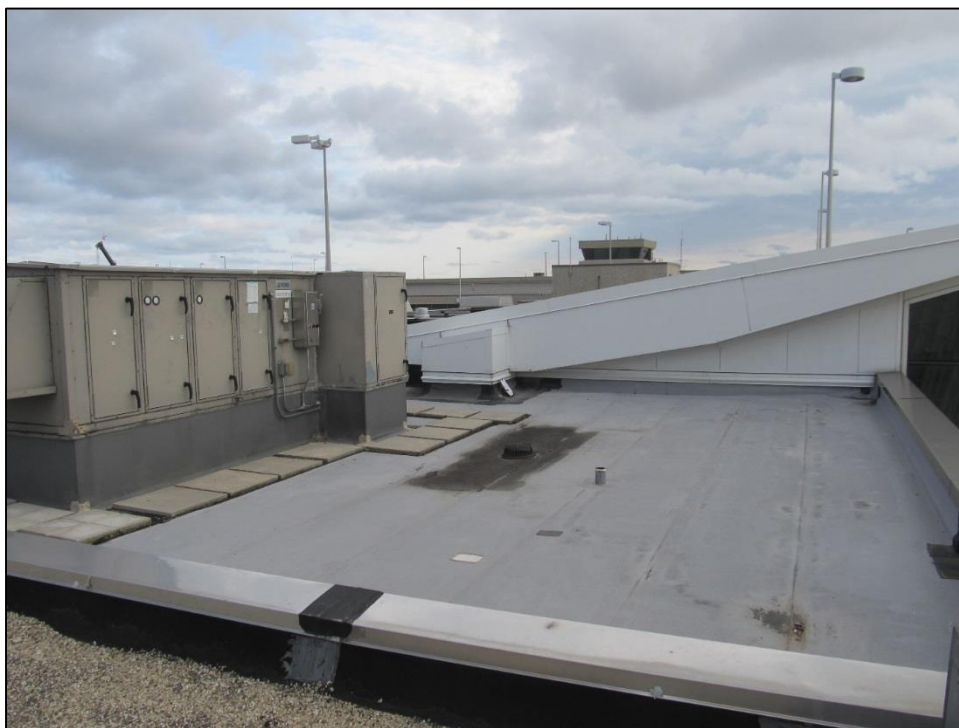
Roof Section	D-20
Estimated Age	24-29
Roof Area (SF)	780
Structural Deck	Concrete
Drainage	Roof Drain
Vapor Retarder	-
Insulation	1" Phenolic Foam, Tapered Perlite
R-Factor	Varies
Membrane	TPO-Mechanically Attached
Flashing	TPO
Surfacing	-
Estimated Roof Service Life	1-3
Replacement Cost	\$8,250
Annual Maintenance Budget	\$400

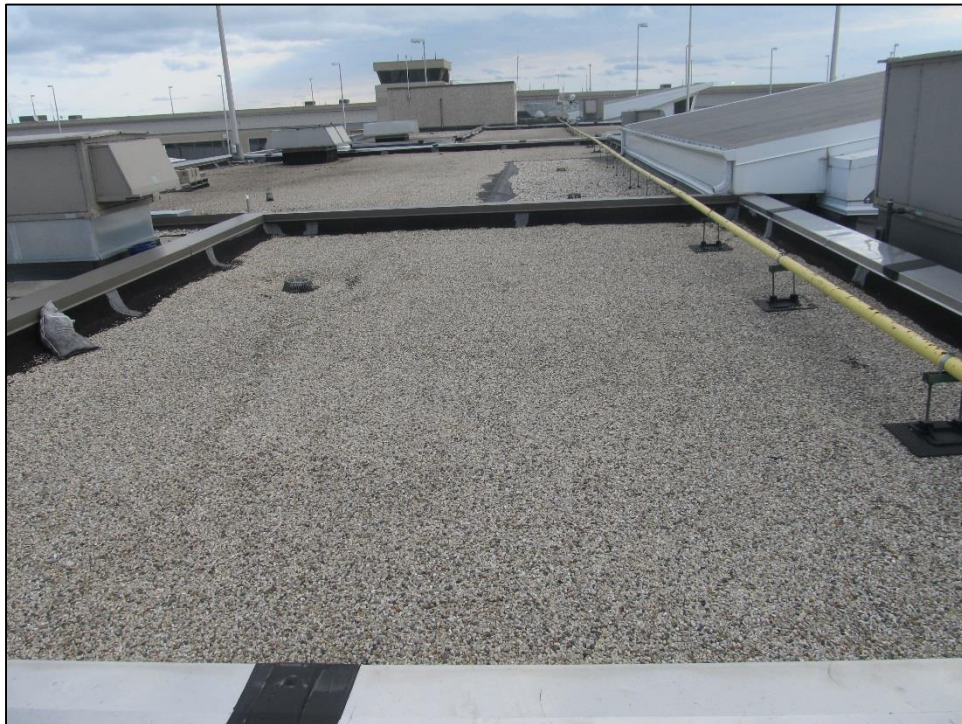
Roof Section	D-21
Estimated Age	24-29
Roof Area (SF)	630
Structural Deck	Concrete
Drainage	Roof Drains & Scuppers
Vapor Retarder	Yes
Insulation	Asphaltic Fill, Perlite
R-Factor	Varies
Membrane	Built-Up
Flashing	Smooth Surfaced Modified
Surfacing	Gravel
Estimated Roof Service Life	1-3
Replacement Cost	\$7,200
Annual Maintenance Budget	\$400

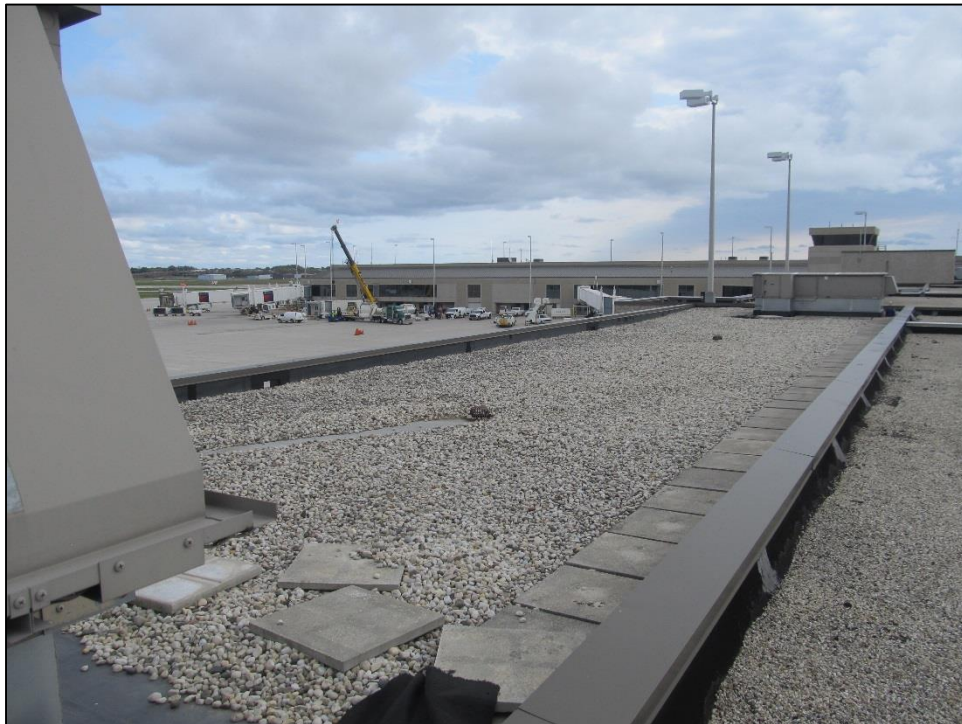
Roof Section	D-22
Estimated Age	24-29
Roof Area (SF)	2,775
Structural Deck	Concrete
Drainage	Roof Drains & Scuppers
Vapor Retarder	-
Insulation	Asphaltic Fill, Perlite
R-Factor	Varies
Membrane	EPDM-Ballasted
Flashing	EPDM
Surfacing	Ballast
Estimated Roof Service Life	1-3
Replacement Cost	\$29,750
Annual Maintenance Budget	\$500

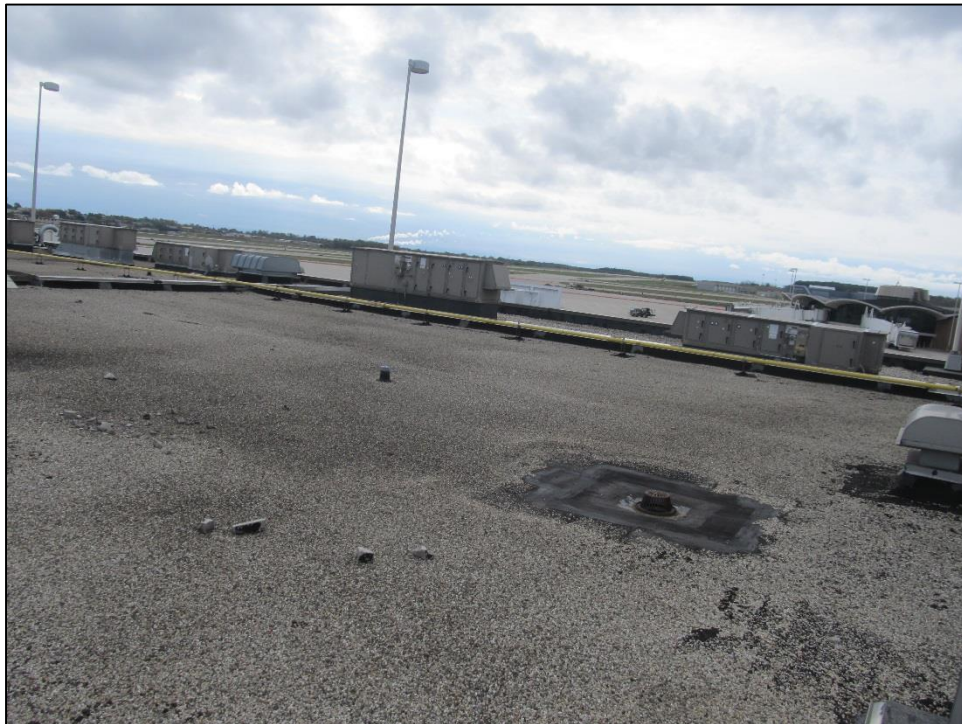
Roof Section	D-23
Estimated Age	24-29
Roof Area (SF)	3,726
Structural Deck	Concrete
Drainage	Roof Drains & Scuppers
Vapor Retarder	Yes
Insulation	Asphaltic Fill, Perlite
R-Factor	Varies
Membrane	Built-Up
Flashing	Smooth Surfaced Modified
Surfacing	Gravel
Estimated Roof Service Life	1-3
Replacement Cost	\$40,265
Annual Maintenance Budget	\$750

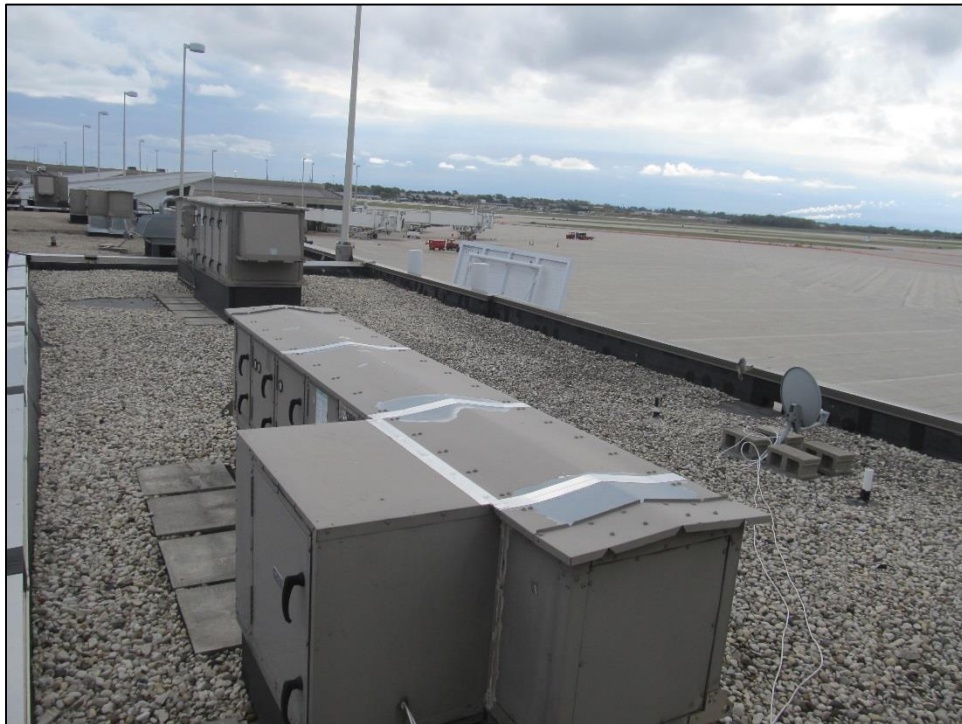
Roof Section	D-24
Estimated Age	24-29
Roof Area (SF)	1,550
Structural Deck	Concrete
Drainage	Roof Drains
Vapor Retarder	-
Insulation	Tapered Poly
R-Factor	Varies
Membrane	EPDM-Ballasted
Flashing	EPDM
Surfacing	Ballast
Estimated Roof Service Life	1-3
Replacement Cost	\$16,500
Annual Maintenance Budget	\$475

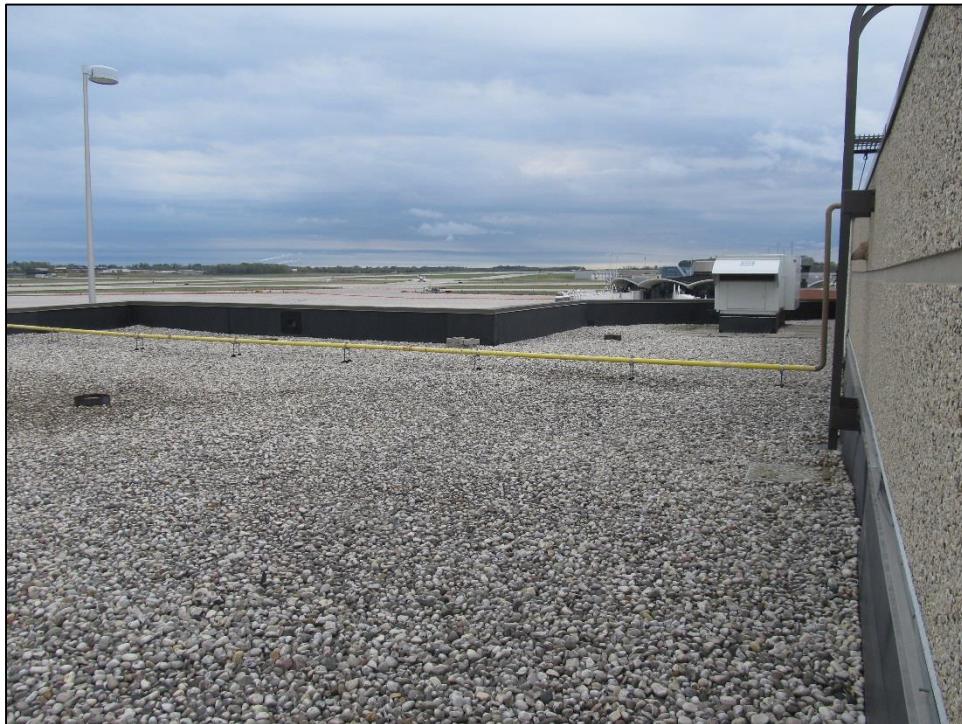
Roof Section	D-25
Estimated Age	24-29
Roof Area (SF)	3,072
Structural Deck	Concrete
Drainage	Roof Drains & Scuppers
Vapor Retarder	Yes
Insulation	Asphaltic Fill, Perlite
R-Factor	Varies
Membrane	Built-Up
Flashing	Smooth Surfaced Modified
Surfacing	Gravel
Estimated Roof Service Life	1-3
Replacement Cost	\$32,750
Annual Maintenance Budget	\$750

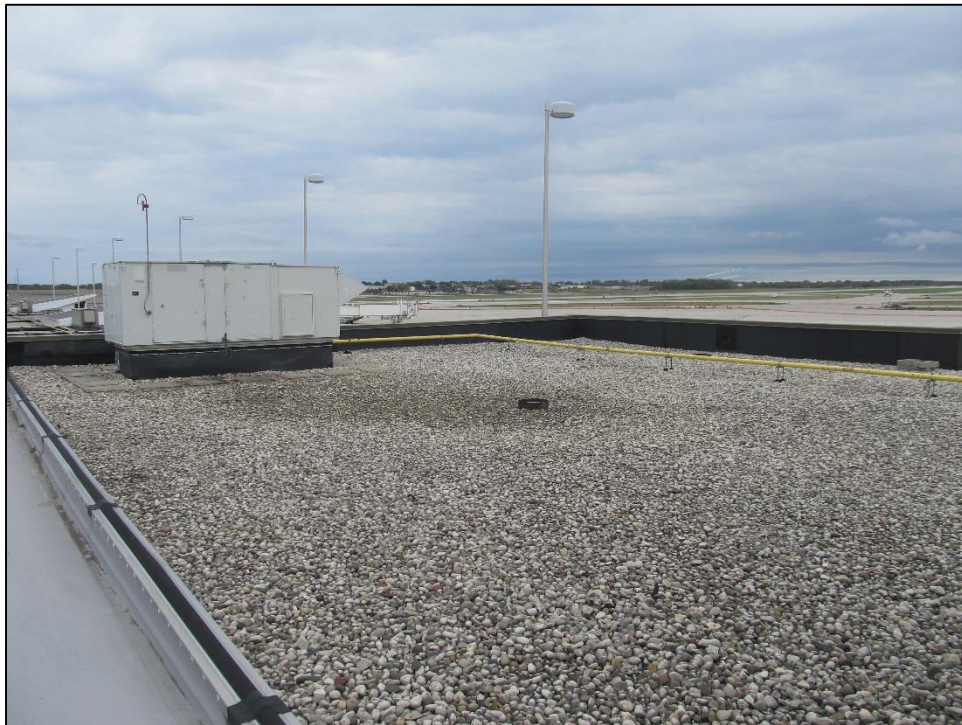
Roof Section	D-26
Estimated Age	24-29
Roof Area (SF)	3,370
Structural Deck	Metal
Drainage	Roof Drains & Scuppers
Vapor Retarder	-
Insulation	2" Poly
R-Factor	8
Membrane	EPDM-Ballasted
Flashing	EPDM
Surfacing	Ballast
Estimated Roof Service Life	1-3
Replacement Cost	\$35,750
Annual Maintenance Budget	\$750

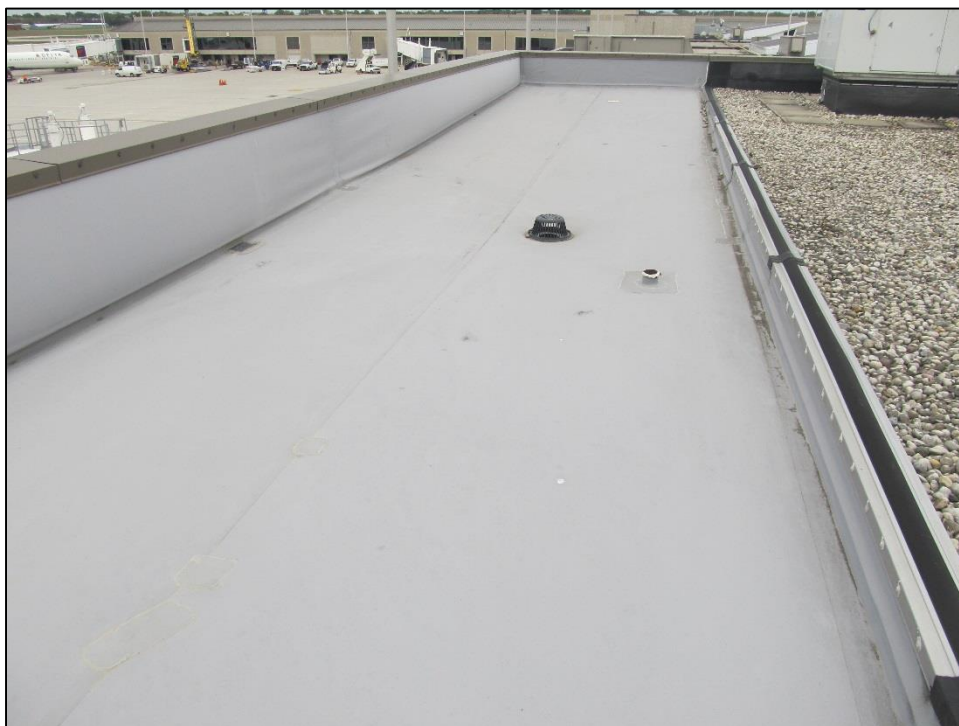
Roof Section	D-27
Estimated Age	24-29
Roof Area (SF)	792
Structural Deck	Concrete
Drainage	Roof Drains
Vapor Retarder	-
Insulation	1" Phenolic Foam, Tapered Perlite
R-Factor	Varies
Membrane	TPO-Mechanically Attached
Flashing	TPO
Surfacing	-
Estimated Roof Service Life	1-3
Replacement Cost	\$8,500
Annual Maintenance Budget	\$350

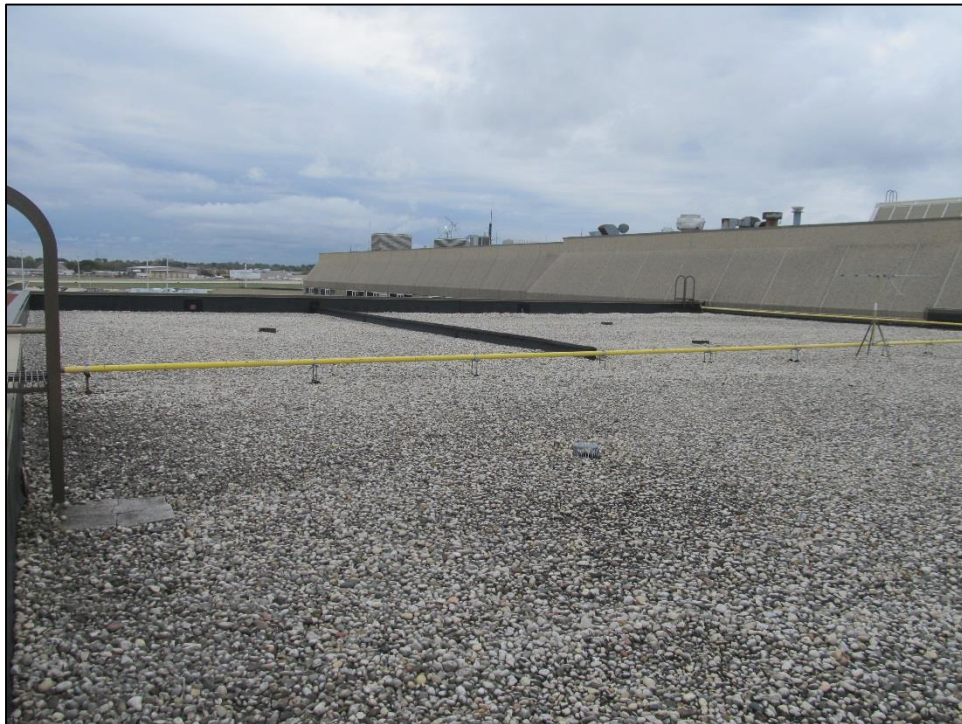
Roof Section	D-28
Estimated Age	24-29
Roof Area (SF)	8,710
Structural Deck	Metal
Drainage	Roof Drains & Scuppers
Vapor Retarder	-
Insulation	2" Poly, Tapered Poly
R-Factor	Varies
Membrane	EPDM-Ballasted
Flashing	EPDM
Surfacing	EPDM
Estimated Roof Service Life	1-3
Replacement Cost	\$95,750
Annual Maintenance Budget	\$1,200

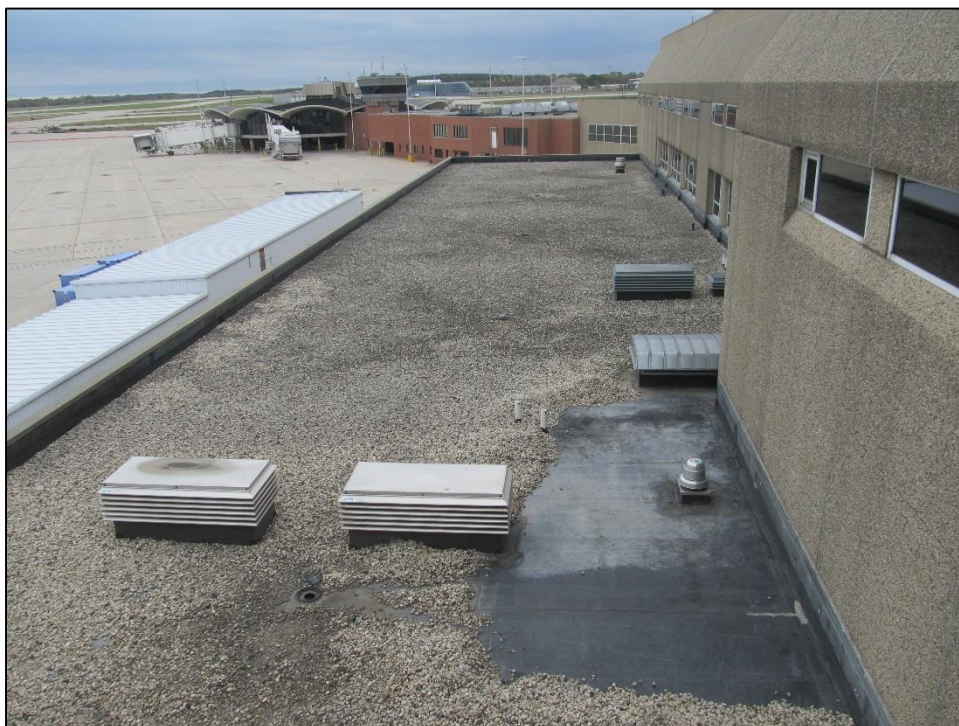
Roof Section	D-29
Estimated Age	24-29
Roof Area (SF)	11,845
Structural Deck	Concrete
Drainage	Roof Drains
Vapor Retarder	-
Insulation	Tapered Poly
R-Factor	Varies
Membrane	EPDM-Ballasted
Flashing	EPDM
Surfacing	Ballast
Estimated Roof Service Life	1-3
Replacement Cost	\$130,250
Annual Maintenance Budget	\$1,200

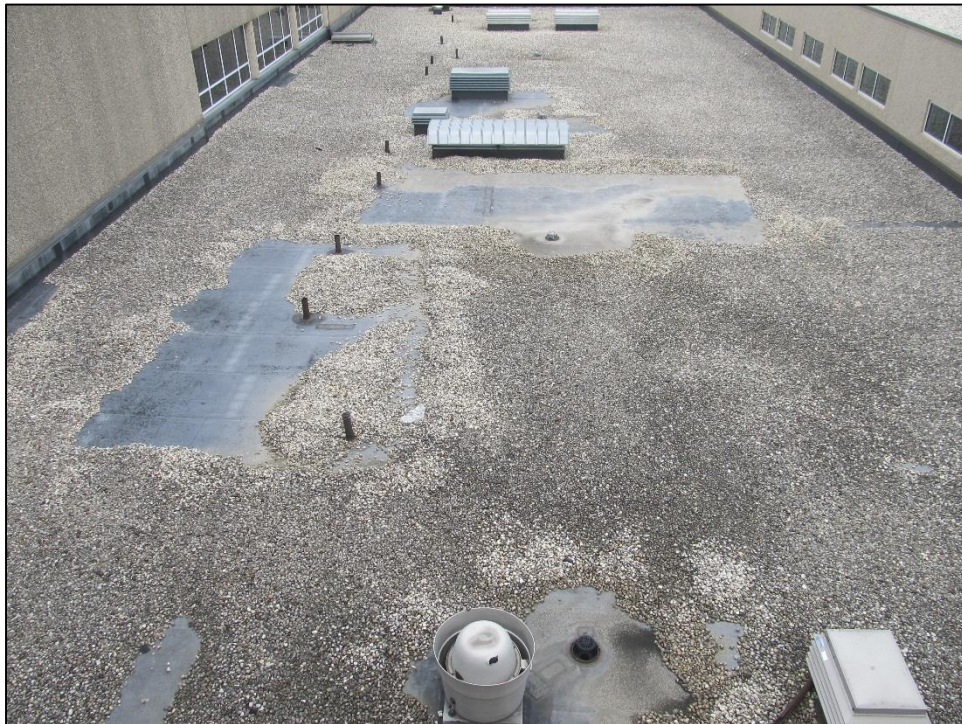
Roof Section	D-30
Estimated Age	24-29
Roof Area (SF)	16,110
Structural Deck	Concrete
Drainage	Roof Drains & Scuppers
Vapor Retarder	-
Insulation	Tapered Poly
R-Factor	Varies
Membrane	EPDM-Ballasted
Flashing	EPDM
Surfacing	Ballast
Estimated Roof Service Life	1-3
Replacement Cost	\$177,250
Annual Maintenance Budget	\$1,200

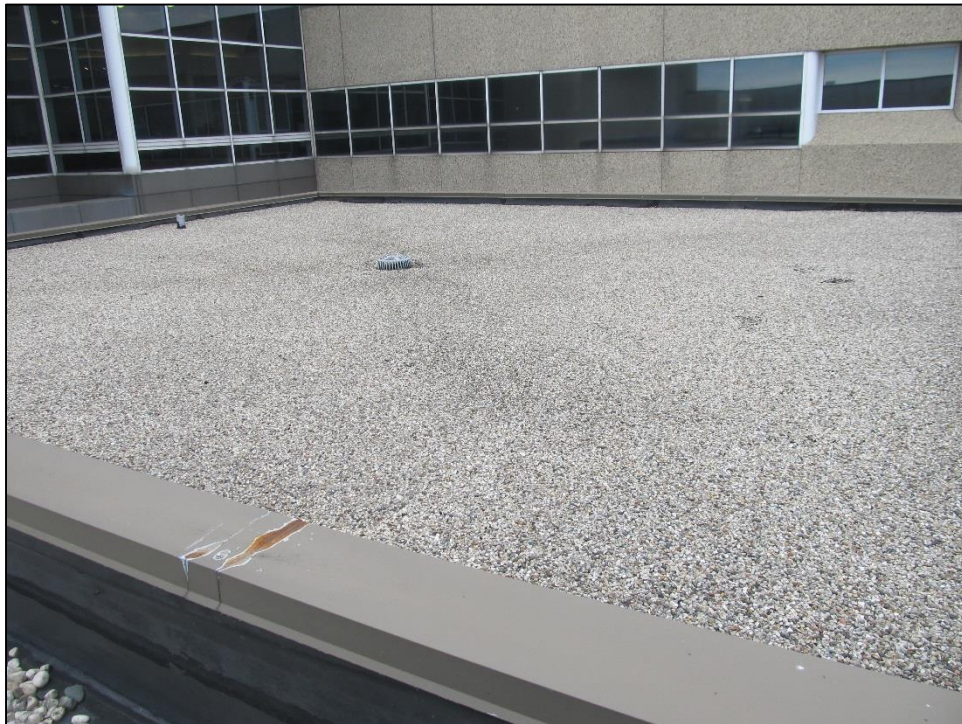
Roof Section	D-31
Estimated Age	14-19
Roof Area (SF)	750
Structural Deck	Metal
Drainage	Roof Drains
Vapor Retarder	-
Insulation	Tapered Polyiso, ¾" Perlite
R-Factor	Varies
Membrane	Built-Up
Flashing	Modified Bitumen
Surfacing	Gravel
Estimated Roof Service Life	10+
Replacement Cost	\$8,250
Annual Maintenance Budget	\$400
